Navajo Abandoned Uranium Mine Site Screen Report

Red Cap AUM Site

Navajo AUM Eastern Region

May 2009

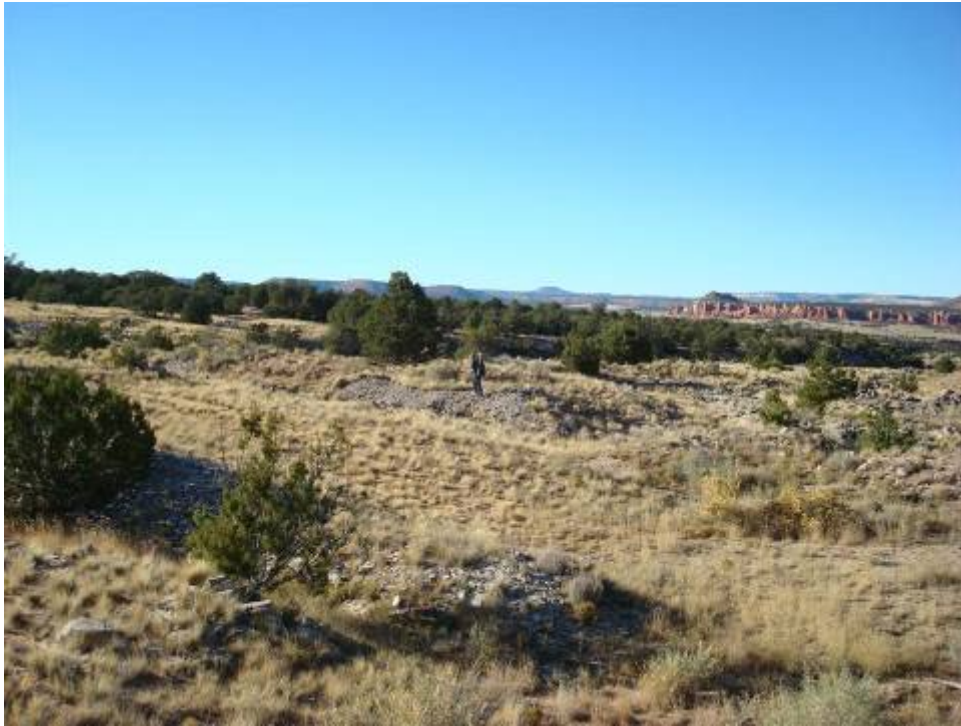
Photo 1. Red Cap mine site, towards the west

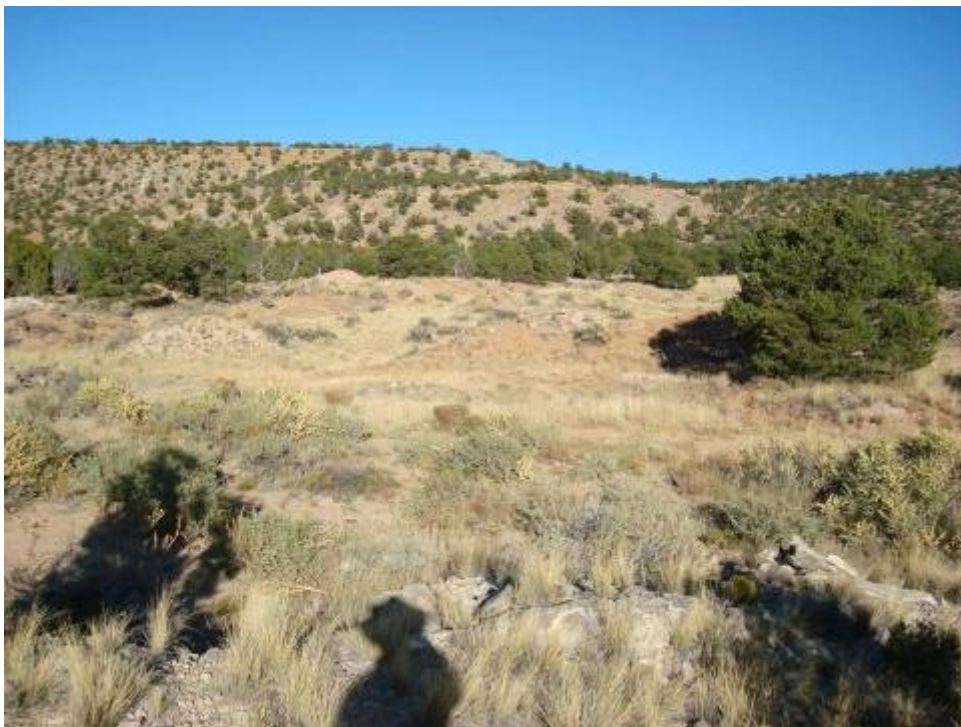
Photo 2. Red Cap mine site, towards the east

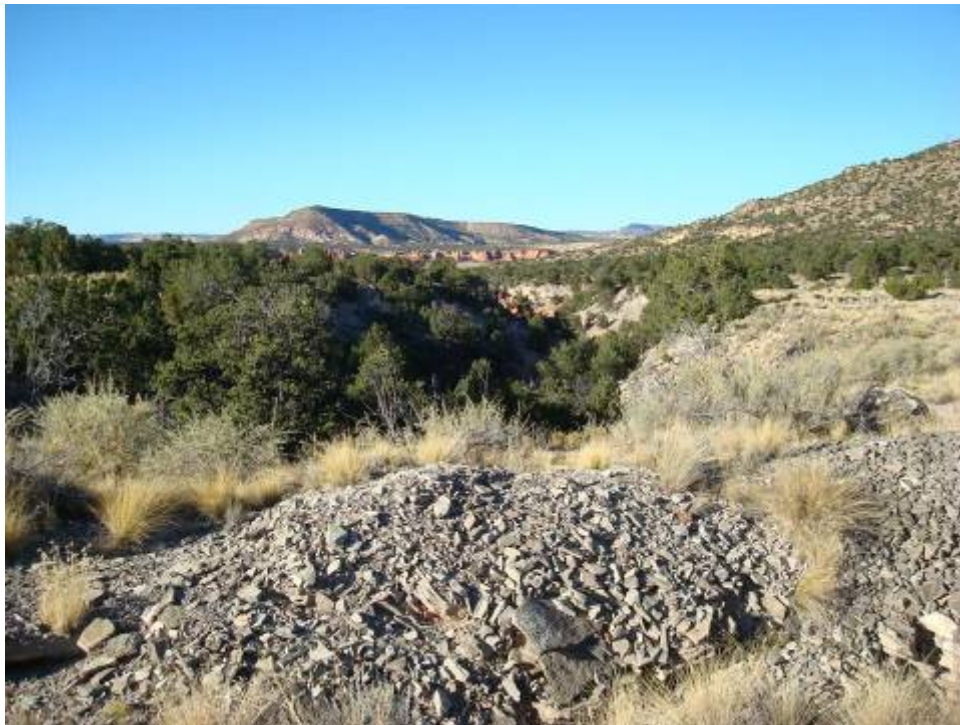
Reclamation status of the mine sites are currently unknown. No visible signs of reclamation were observed. Numerous waste rock piles are found throughout the site. The mining appears to have been conducted from exposed bedrock at the surface. Blast holes were found in some areas. No adits or other mine features were observed during the site visit.

Photo 3. Red Cap mine site, waste rock piles

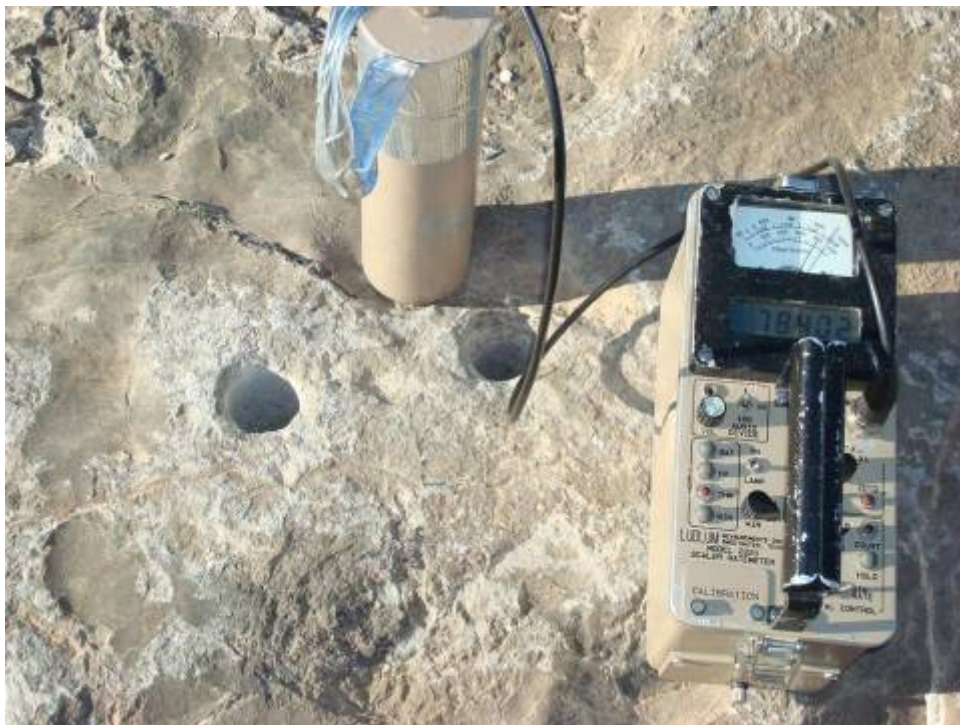
Photo 4. Red Cap mine site, bedrock exposure and blast holes

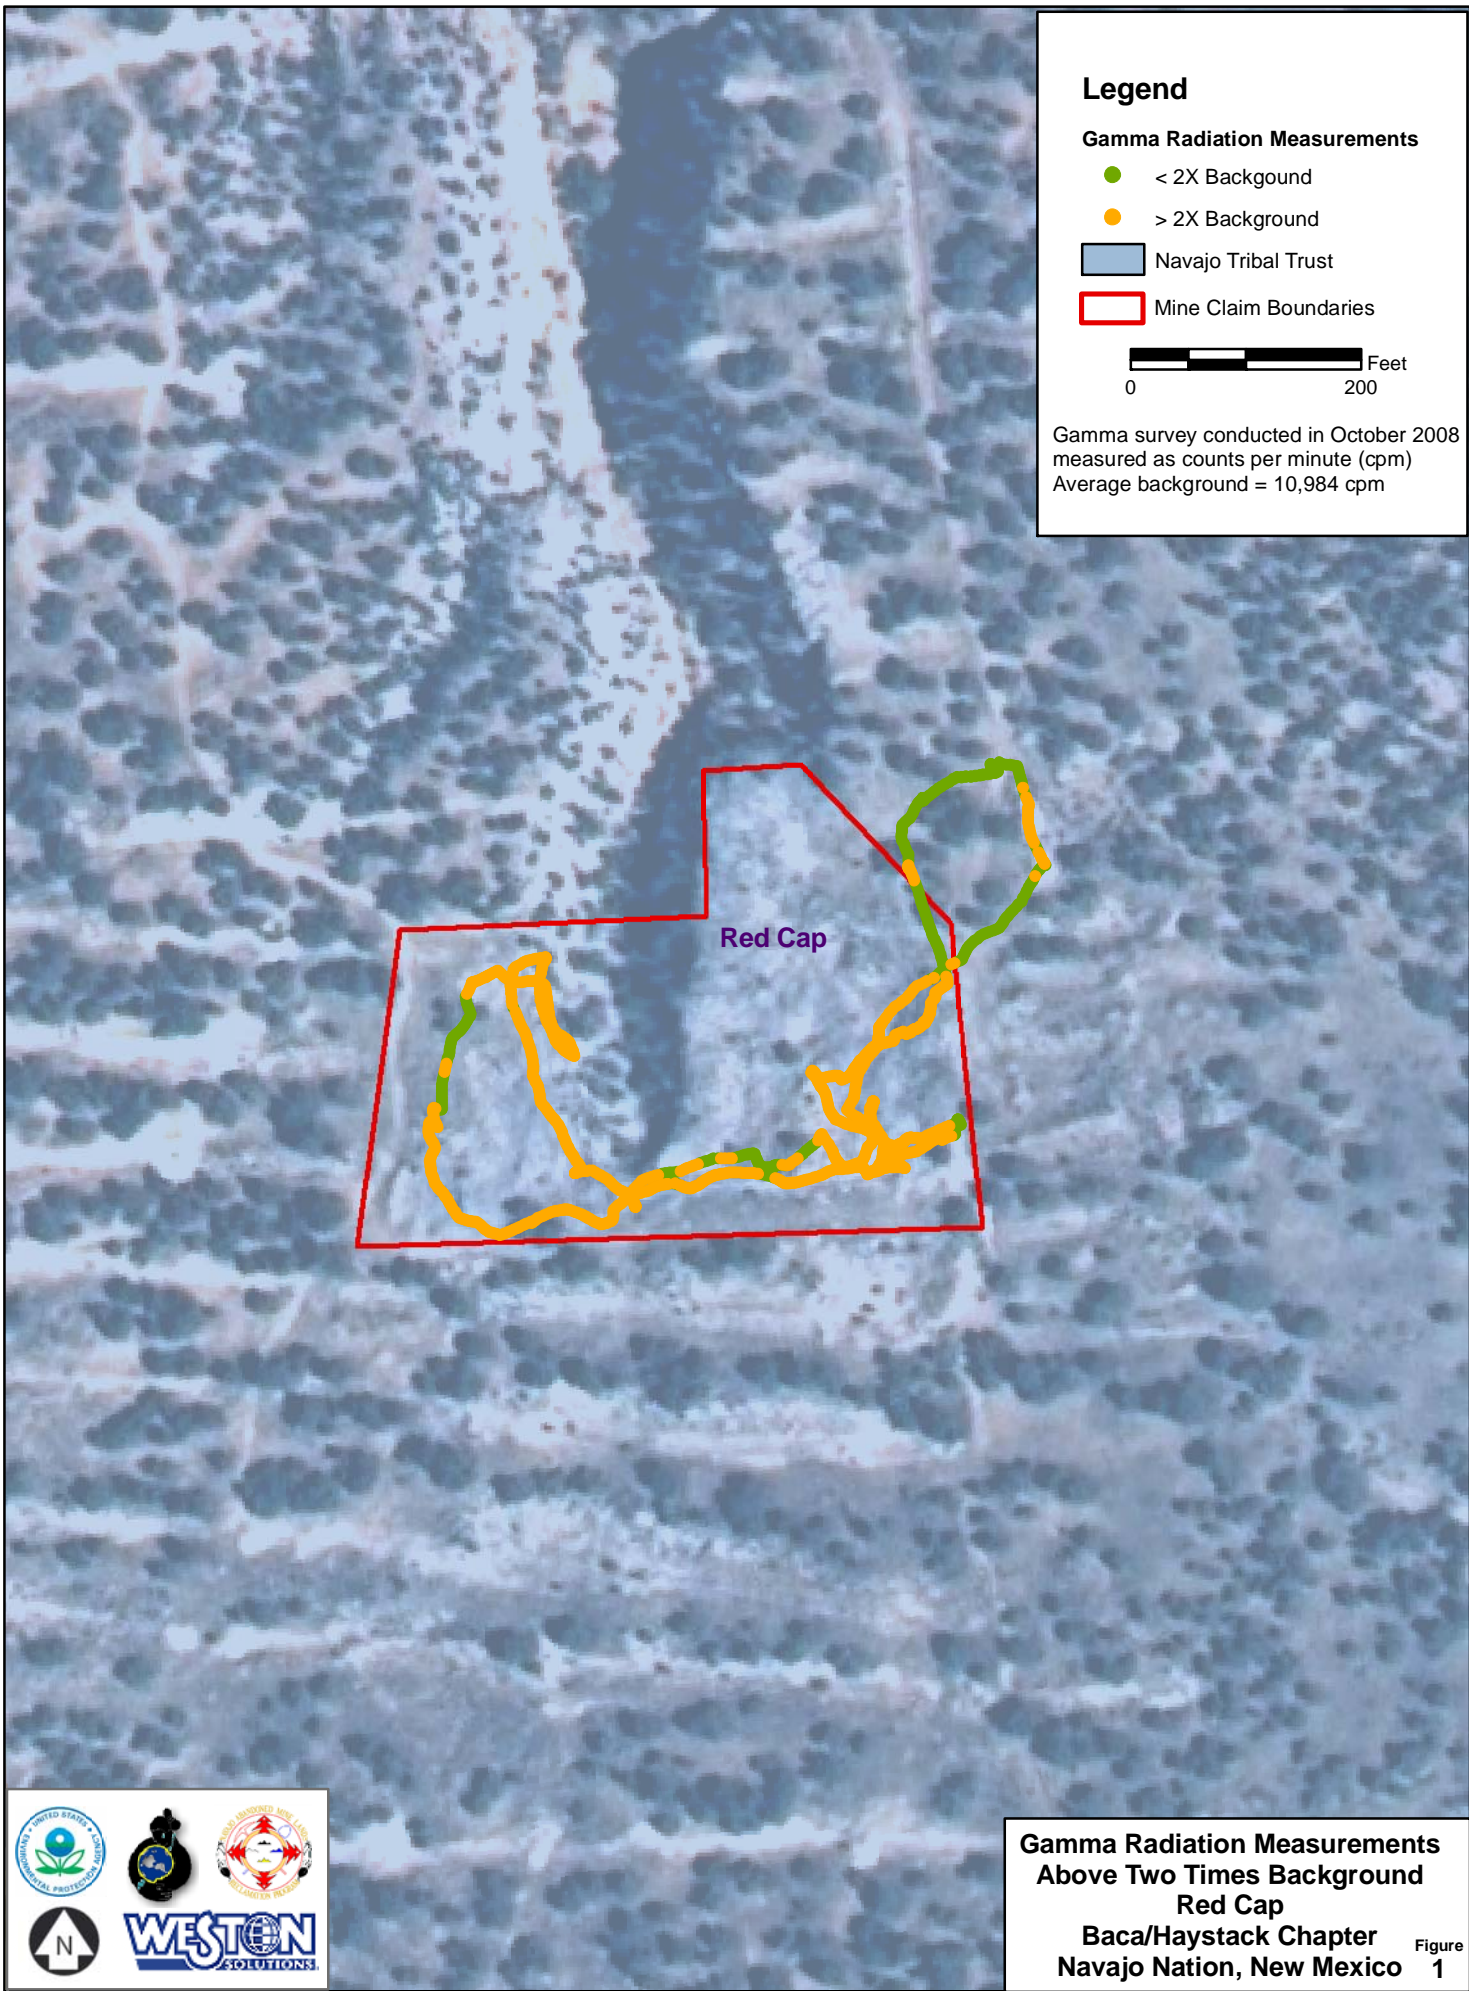
Figure
1

A total of 1,845 gamma radiation measurements were collected from mine sites, ranging from 6,705 cpm to 398,613 cpm. The measurements are represented in Figures 1 and 2.

Gamma survey conducted in October 2008
measured as counts per minute (cpm)
Average background = 10,984 cpm

Gamma Radiation Measurements
Above Two Times Background
Red Cap

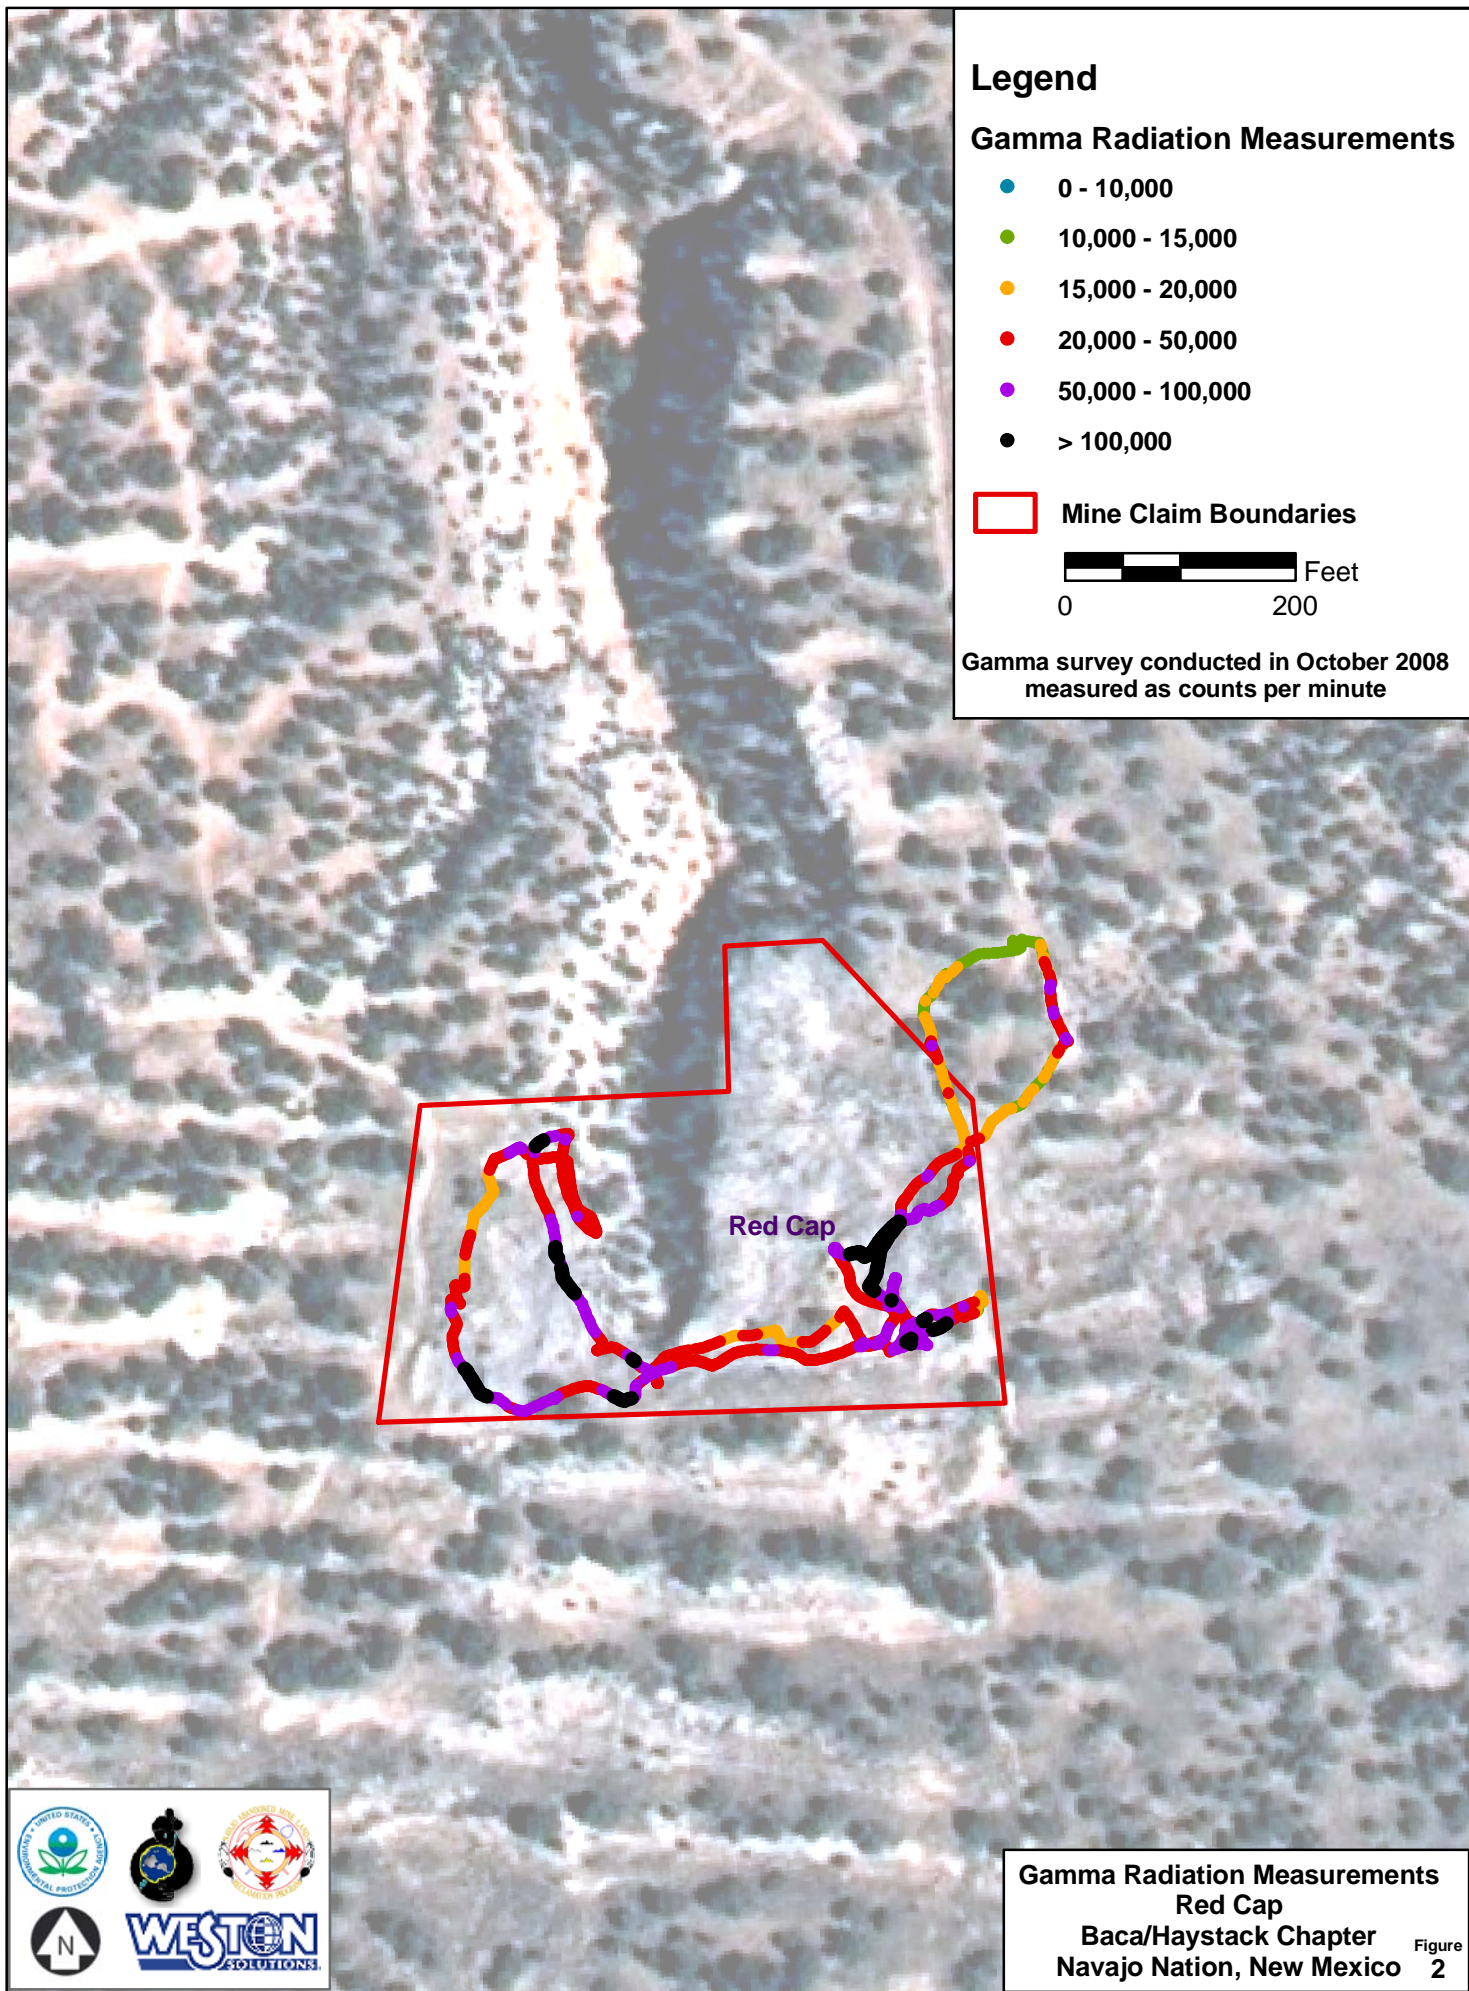
Figure
2

Gamma survey conducted in October 2008
measured as counts per minute

Gamma Radiation Measurements
Red Cap
Baca/Haystack Chapter
Navajo Nation, New Mexico
